CHAPEL HILL UNITED METHODIST

Oklahoma City, Oklahoma

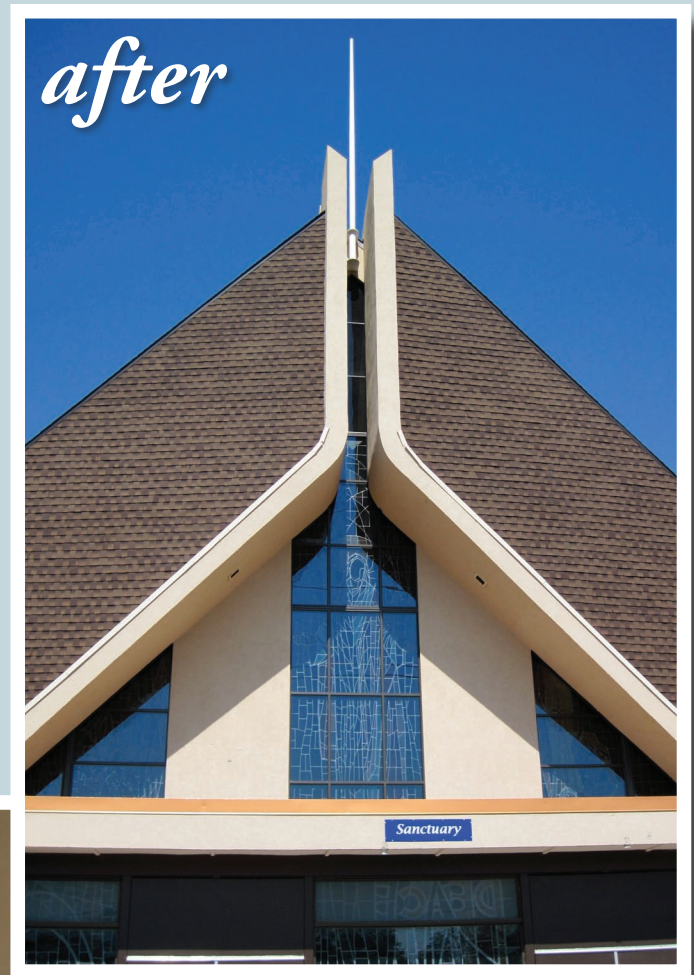
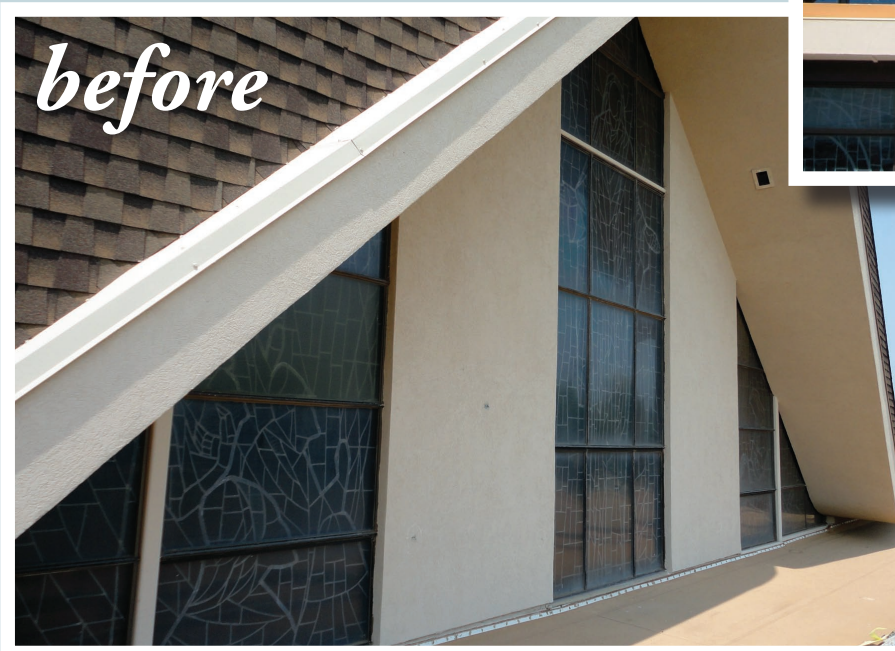
Another hail storm hit in 2012, and although the protected windows did not have any damage, stained glass pieces on windows which had not been covered were broken and a clouded, brittle polycarbonate covering on the largest window leaked and billowed. The broken glass was once repaired, and the old polycarbonate on the window shown below was removed and replaced with a tempered glass.

A tempered glass protective covering was also installed in a bronze-toned, aluminum, vented frame on the chapel windows so they will also be protected from future hail storms.

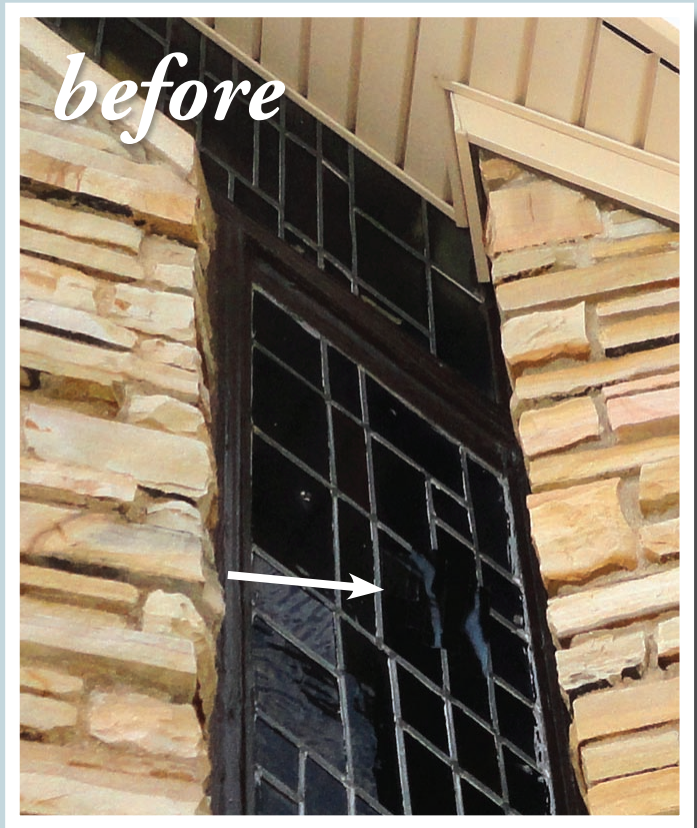
To the right, a piece of black tape patched up broken glass from the hail storm.

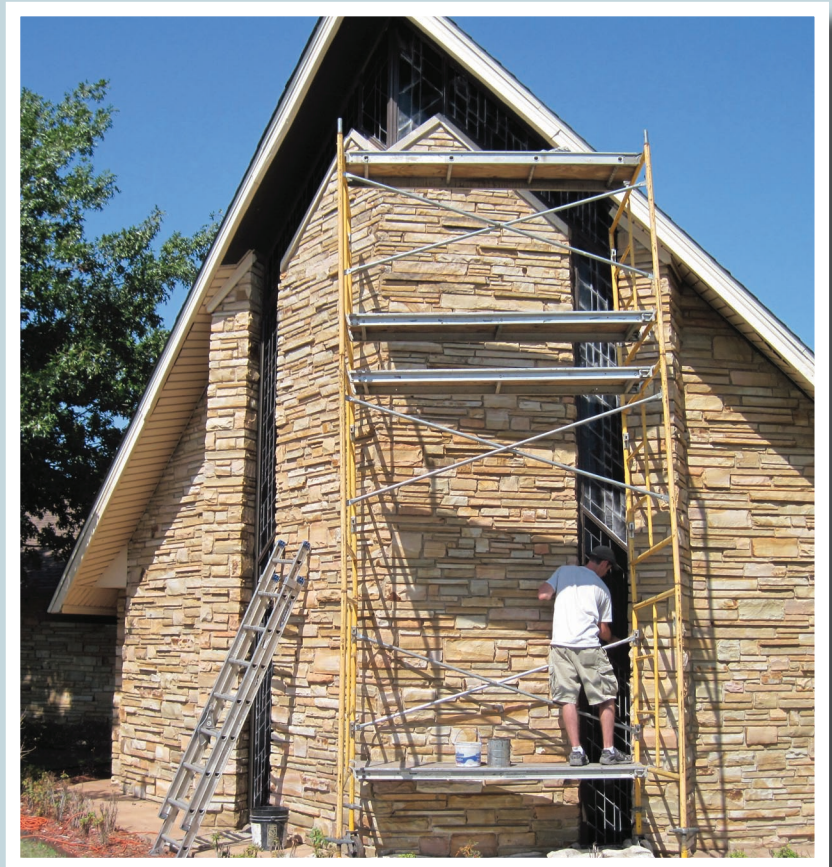
This hidden venting system allows heat build-up to escape.
