ST. ANTHONY OF PADUA PARISH

Okeene, Oklahoma

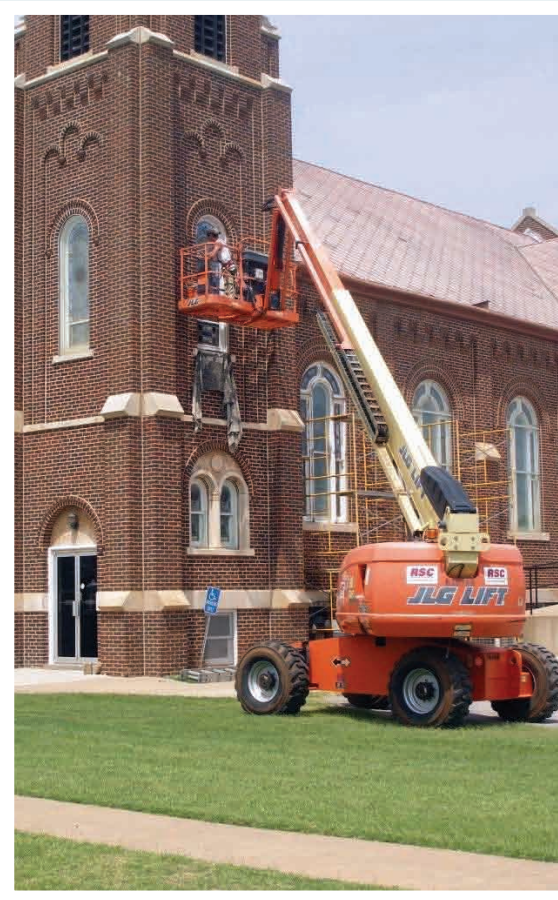
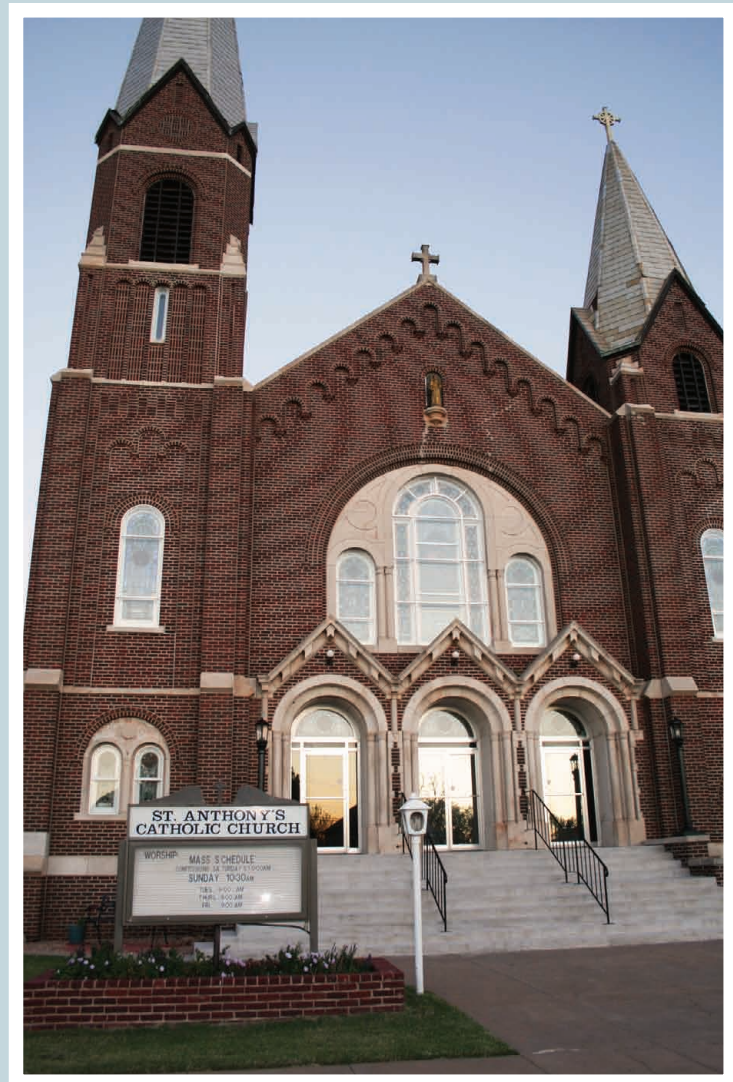
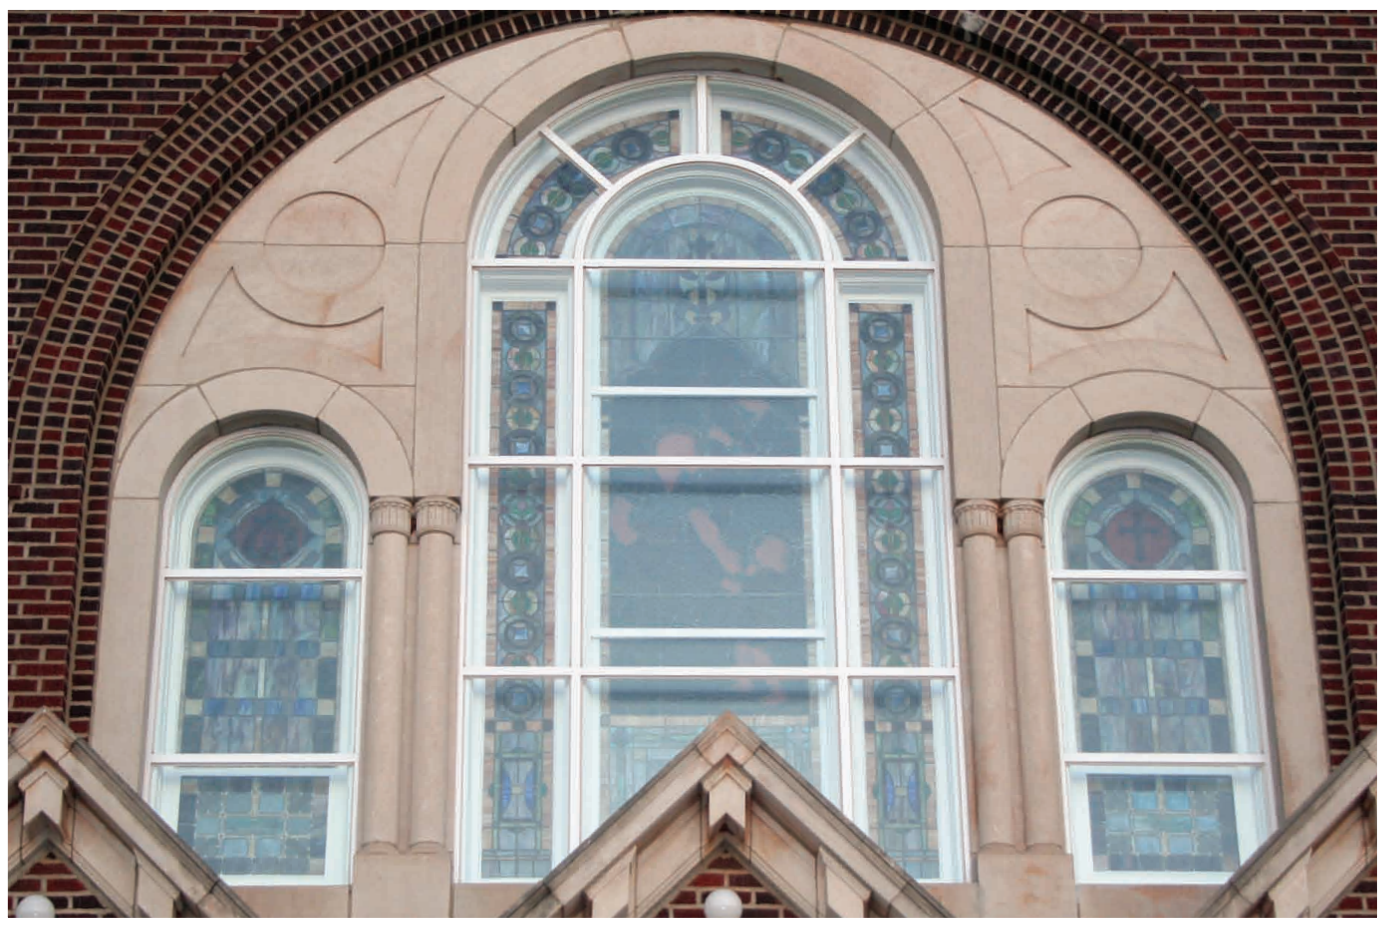
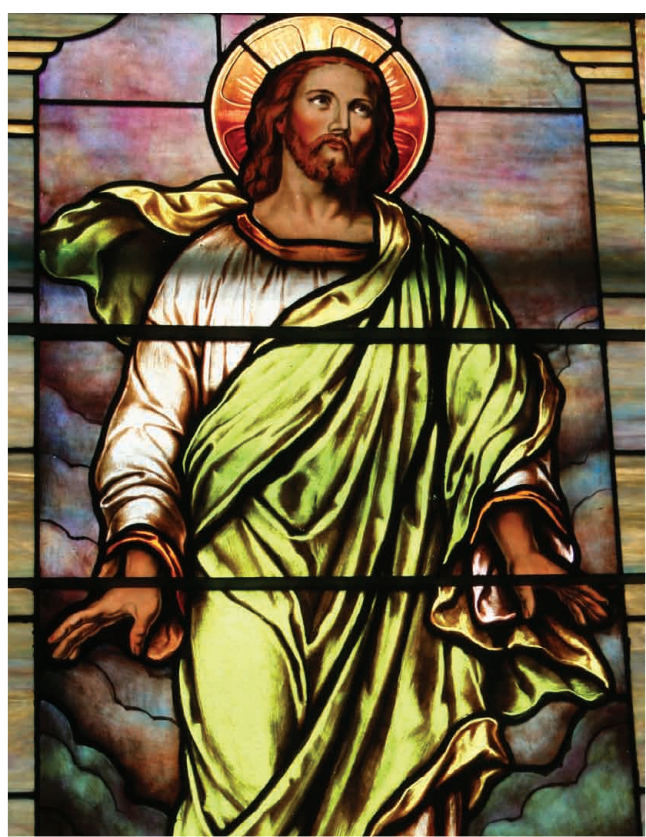
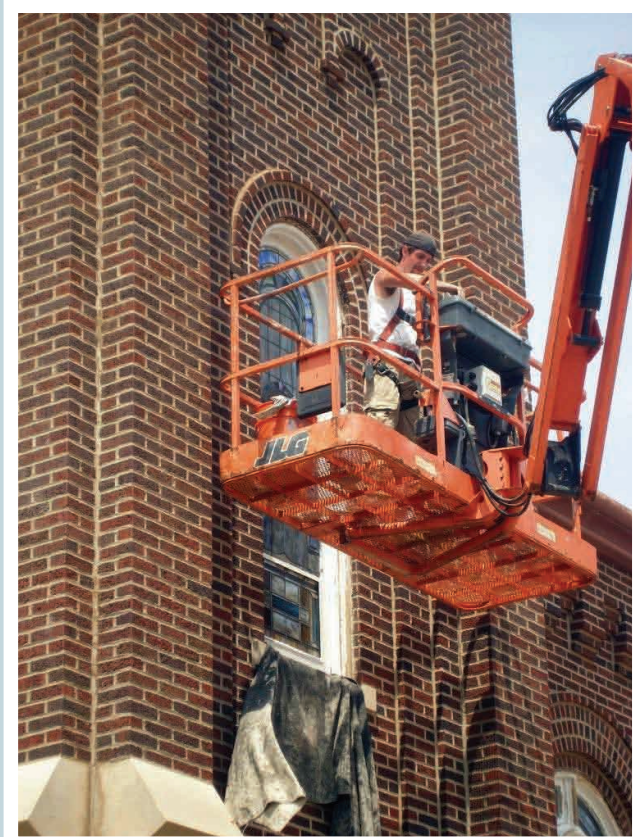
The windows at St. Anthony of Padua Parish had a number of bulges and broken stained glass pieces. Following restoration of the windows, including replacing broken pieces and flattening bulges, the windows were covered in new protective covering using a white, vented perimeter frame.
