CATHEDRAL OF THE PLAINS

Victoria, KS

The polycarbonate protective covering over the Munich stained glass at the landmark Cathedral of the Plains had become cloudy and brittle. New 1/4" tempered glass was installed using a vented, anodized aluminum perimeter framing system.

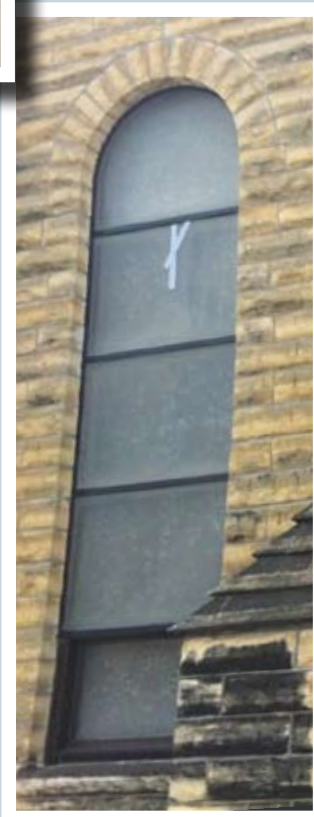
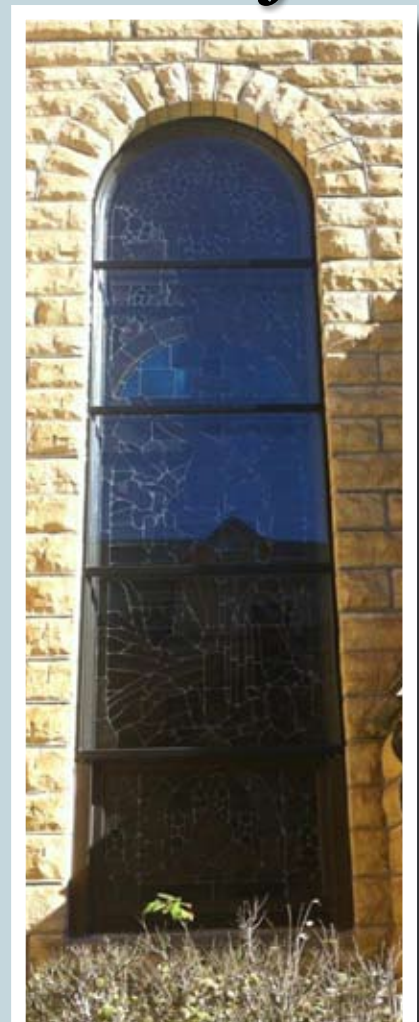
after

before
